Mankowski, O. and Wang, Q. (2013) 'Real-time monitoring of wind turbine generator shaft alignment using laser measurement.', *Procedia CIRP*, 11 . pp. 291-295.

2nd International Through-life Engineering Services Conference

Real-time Monitoring of Wind Turbine Generator Shaft Alignment using Laser Measurement

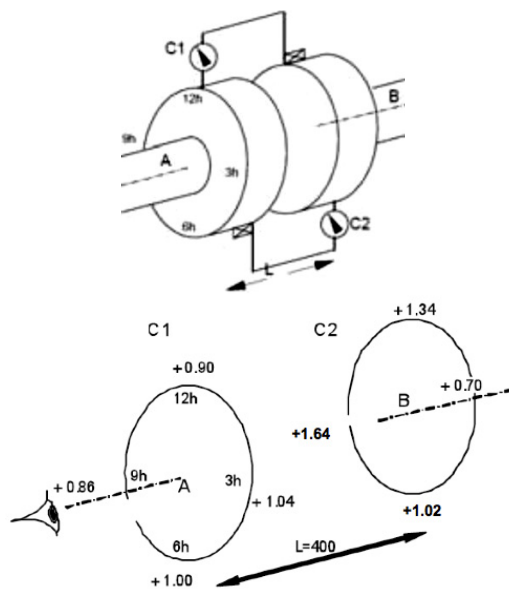
Fig. 1. Shaft alignment procedure

The 'C1' and 'C2' locations are measurements located at an angular difference of 180° . The longer the distance of 'L' is the better, as it increases the sensitivity of angular error detection. The readings should be performed at least 4 times for the 'C1' and 'C2' measurement locations: that being at the 12h, 3h, 6h, 9h clock-wise locations. The results from these measurements can then be evaluated as in Figure 2. The values given are an example in millimetres, where the reading is considered positive (+) when the measurement is towards the shaft. In assessing the measurements referring to the vertical plane, the deflections are shown below as an example:

Though small degrees of misalignment do not cause transmission losses, it is still a serious concern. Lin et al detected the motor shaft alignment using multiscale entropy with wavelet denoising [5]. Lees investigated the misalignment in rigidly coupled rotors [6], Pennacchi et al modelled the nonlinear effects caused by coupling misalignment in rotors [7]. However these tests tend to be one-off tests and are not conducted based upon shaft misalignment and additionally there is no regular monitoring. In order to perform regulator monitor, measurements need to be taken as in Figure 1, from Vesta [8], below:

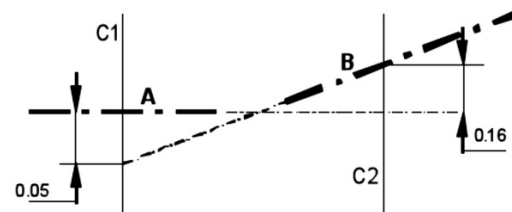
Considering the vertical plane of 'C1', the vertical action towards the top of shaft 'A' on the measurement device is dominant. In the plane 'C1' the axis 'A' is higher than axis 'B' (at 0.05mm average deflection at 180° opposed measurements). In the vertical plane measurement 'C2', as shown in Figure 2, shows that the vertical action towards the top of shaft 'B' measured is greater. In the plane 'C2' the axis 'B' is higher than axis 'A' at 0.16mm. Therefore in the vertical plane the angular alignment error can be evaluated as 0.0525 mm.

Fig. 2. Eccentricity calculation geometry – vertical axis

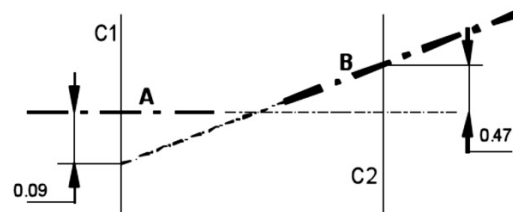
In this plane, 'C1', the axis 'B' is further to downwards than 'A' at 0.09mm of deflection. In the plane 'C2' the axis 'B' is further upwards than 'A' at 0.47mm of deflection (again, average deflection at 180° opposed measurements). As such the horizontal angular error can be evaluated as 0.14mm.

Fig. 3. Eccentricity calculation geometry – horizontal axis

Measurements can therefore also be taken referring to the horizontal axis, as shown in Figure 3 below:

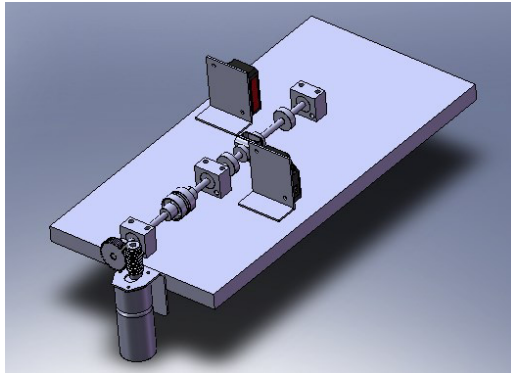
In order to perform real-time shaft alignment, a laboratory test rig has been created that operates at the typical rotational rates of a wind turbine in the order of 120rpm using two lasers. The general assembly, as shown in Figure 4 is a motor that simulates the turbine rotating, connected via a straight shaft to two flanged couplings and a flexible coupling. Two measurement devices evaluate the distance to pulleys

mounted on both sides of the motor shaft flanged and also flexible coupling (to separate tests). These lasers determine the variation in radii of the shaft as it rotates. A photosensitive sensor is used as a rotary encoder to determine when the shaft has completed a rotation, and via an electronic comparator, gives a TTL trigger signal. Additionally the alignment calculation, as shown in Figure 2 and Figure 3, to determine horizontal and vertical alignment can be computed 'on the fly' and hence the measurement of misalignment can be readily evaluated. The test was conducted on both the flanged coupling used to test radial misalignment and the flexible coupling used to test axial angular misalignment.

Fig. 4. Shaft alignment test rig CAD model

In this test, the physical structural deformation of the shaft is not experimented as the lasers would equally measure alignment error whether it was caused by poorly connected couplings or shaft deformation, either way each result would show a delta movement in shaft distance.

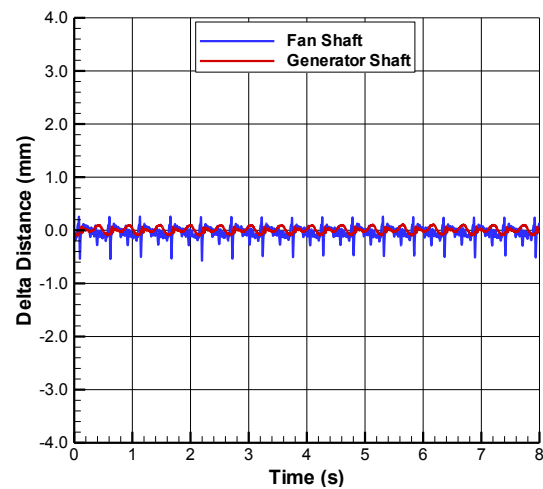
Results for this test configuration can be seen in Figure 5 showing the results for multiple shaft rotations, and then Figure 6, showing the results ensemble-averaged for the periods shown in Figure 5. The results are interpreted by looking at differences in the average between the two sides of

Fig. 5. Flanged coupling, laterally aligned, time history data

the coupling (which shows shaft misalignment) and then variation in amplitude as the shaft rotates (which represents eccentricity of the coupling alignment). So, ideally, the shafts will have the same average and little amplitude variation during rotation. It can be seen that when the flanges are correctly aligned, the variation in distance of the coupling wall varies only nominally though a minor variation of a few decimals of a millimetre can be seen. Equally the downstream coupling, representing the fan shaft, also has a nominal coupling wall distance variation. The results of the time history were then time averaged, in Figure 6, which shows very good correlation between the two laser distance measurements. Note the peak seen, especially in the fan shaft trace, which presents the cut-away in the flanged coupling, evident in the images of the flanged coupling presented earlier. No correction is made in any of the results presented for the 180° phase shift between the motors, as the proposed method uses periodic peak-to-peak measurements and as such no alignment of instantaneous measurement result is required.

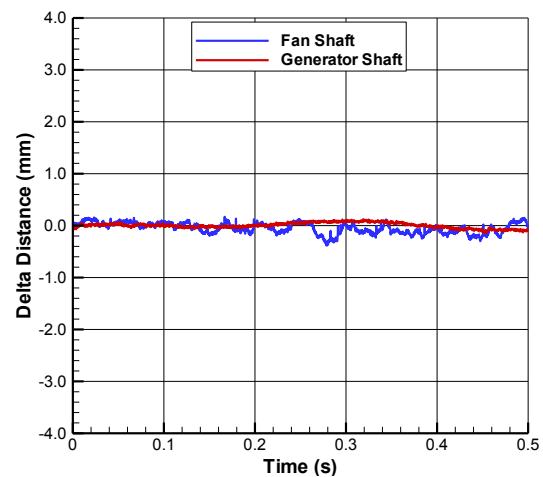
Fig. 6. Flanged coupling, laterally aligned, ensemble averaged data

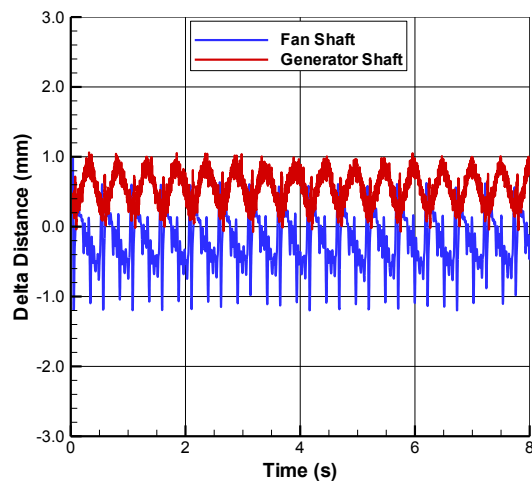
The tests were now repeated with the flanged coupling misaligned, with the time history and ensemble averaged data shown in Figure 7 and Figure 8 respectively. It can now clearly be seen that there is both a DC shift between the fan and generator shaft reading and also periodic amplitude due to the misalignment. The ensemble averaged results also show the clear variation in coupling sidewall distance with rotation, with a clean signal seen for the generator shaft and a more noisy (mainly due to the rapid variation in distance relative to laser response time) trace evident for the fan shaft.

Fig. 7. Flanged coupling, laterally misaligned, time history data

The peak-to-peak variation for the fan shaft was found to be ± 0.49 mm, with an average of $+0.51$ mm, and the peak-to-peak variation for the generator shaft found to be ± 0.38 mm, with an average of ± 0.32 mm. With C_1 as 1.00 and 0.02 mm and C_2 as 0.70 and -0.06 mm, the vertical alignment of drive shafts for lateral misalignment is 0.085 mm and horizontal

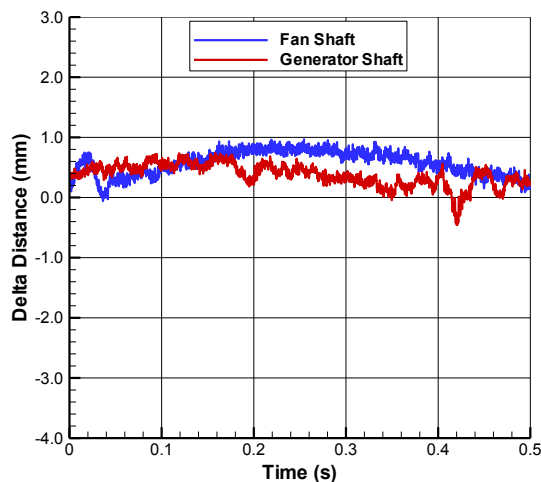
Fig. 8. Flanged coupling, laterally aligned, ensemble averaged data

alignment of drive shafts for lateral misalignment is -0.002 mm.

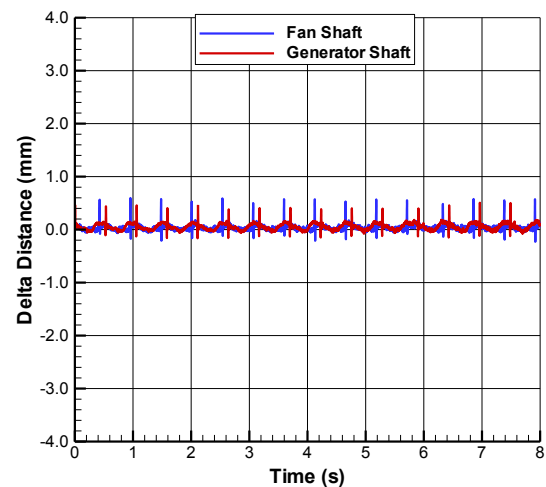
The lasers were then remounted, with the distance measurement targeted on the flexible flange sidewalls, with the results reported in Figure 9 and Figure 10 for the time history and ensemble-averaged data, respectively. It can be seen that there is a nominal sidewall distance variation with shaft rotation on both the fan and generator shaft sides of the coupling, with the spike in the time history data representing the cut-away in the coupling for the fixing grub screw (visible in images of the flexible coupling earlier). The ensemble-averaged data, in Figure 10, also clearly shows neither no DC shift nor periodic variation in the sidewall distance.

Fig. 9. Flexible coupling, axially aligned, time history data

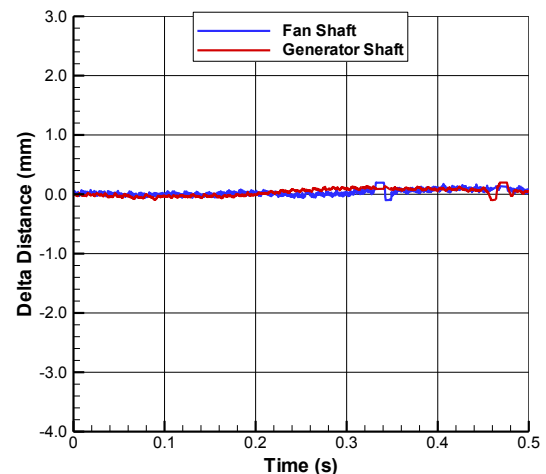
Fig. 10. Flexible coupling, axially aligned, ensemble average data

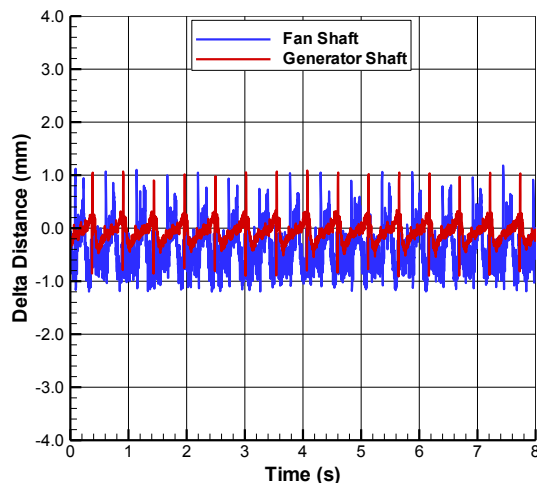
Figure 11 and Figure 12, show the results for the time history and ensemble averaged data, respectively. It can be seen that, though step change exists between the sidewall measurements either side of the coupling, the couplings are clearly out of alignment due to the periodic amplitude. The ensemble-averaged results show much less noisy results relative to the time history, suggesting that the ensemble averaging offers a far clearer result. It can also be seen in the ensemble averaged result prominent peaks where the cut-away for the grub screw is located, and the distinct peak at this location confirms accurate shaft angle triggering (otherwise the peak would be smoothed). The results show that the generator shaft has an average result of -0.12mm and an amplitude of 0.24mm , versus an average of -0.08mm and an amplitude of 0.76mm for the fan shaft measurement. It is expected that the fan shaft deflects more greatly than the generator shaft due to the test rig applying the misalignment on the fan shaft side.

Fig.11. Flexible coupling, axially misaligned, time history data

The peak-to-peak variation for the fan shaft was found to be $\pm 0.56\text{mm}$, with an average of -0.18mm , and the peak-to-peak variation for the generator shaft found to be $\pm 0.28\text{mm}$, with an average of -0.04mm . With C_1 as 0.38 and 0.74mm and C_2 as 0.24 and -0.32mm , the vertical alignment of drive shaft for axial misalignment is 0.031mm and the horizontal alignment of drive shafts for axial misalignment is 0.021mm .

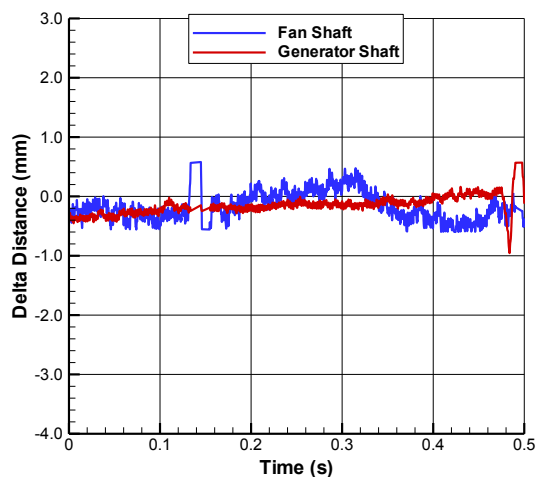
Fig.12. Flexible coupling, axially misaligned, ensemble average data
